**ASSESSMENT OF LAND-USE ACTIVITIES AND THEIR CONTRIBUTION TO  
LAND DEGRADATION IN OROBA WATER CATCHMENT, NANDI/ KISUMU  
COUNTIES, KENYA.**

**A THESIS SUBMITTED TO THE SCHOOL OF ENVIRONMENTAL STUDIES  
IN PARTIAL FULFILLMENT OF THE REQUIREMENTS OF THE DEGREE  
OF MASTERS OF SCIENCE IN ENVIRONMENTAL STUDIES  
(ENVIRONMENTAL PLANNING AND MANAGEMENT), UNIVERSITY OF  
ELDOROT, KENYA**

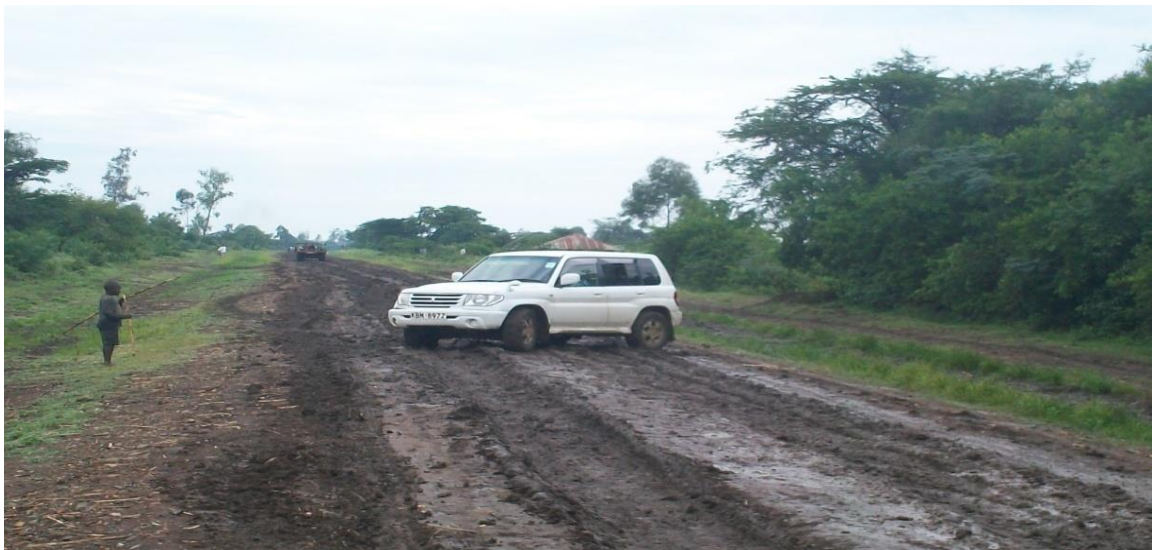
In the Middle catchment, specifically on the steep hilly escarpment the roads are eroded and thus exposing the rocky outcrops and sharp stones that make the road difficult to use by vehicles, and only left to tractors and donkeys transport. The catchment is served with three tarmac roads that pass through to other destinations. The Kisumu - Nairobi, Kisumu - Chemelil in Kisumu County, and Serem - Kaptumo in Nyando County. The Kisumu - Chemelil road is in pathetic condition, this has made transport in that area a nightmare.

**Plate 4. 1: Vehicle stuck in lower Oroba water catchment (Source: Author,2012)**

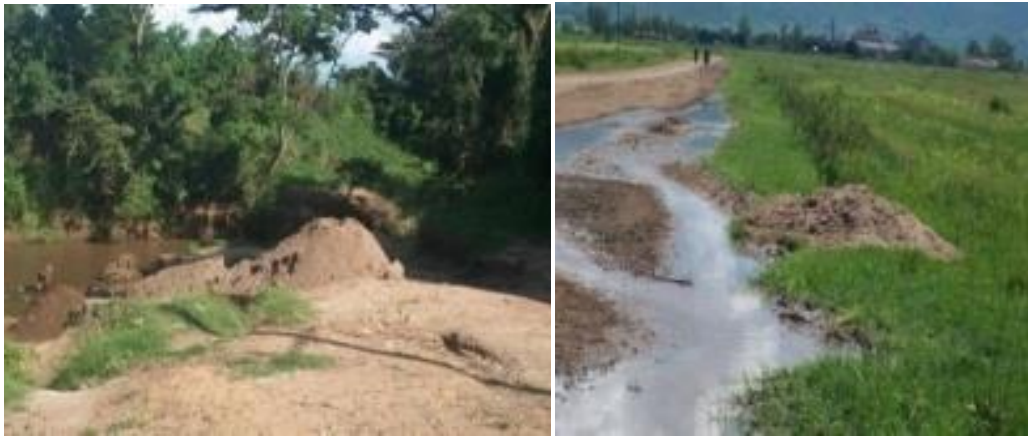
Sand harvesting (Plate 4.2) which is common during rainy seasons generates good income but those done along the road is destructive and accelerates rate of erosion in the catchment, river banks are damaged as well and the river banks end up being eroded hence more eroded material into the streams, rivers and finally to the lake causing heavy siltation (figure 4.13). The poor road maintenance results to road erosion and these eroded materials are deposited into the surface water bodies. The drainage ways normally end up being rendered dysfunctional.

**Plate 4. 2: Sand harvesting in river Oroba and along the road in Oroba lower water catchment (Source: Author, 2012).**

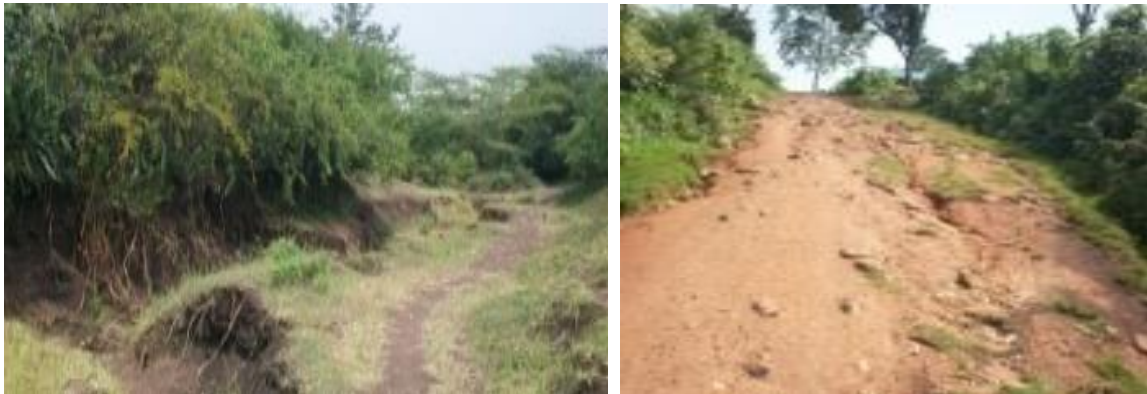
Some of the roads are stony and rocky in the upper catchment ending up with protruded rock outcrops (Plate 4.3) which has lead to some roads impassable during wet and dry weather.

**Plate 4. 3: Roads eroded by water in lower and upper Oroba water catchment (Source: Author, 2012).**

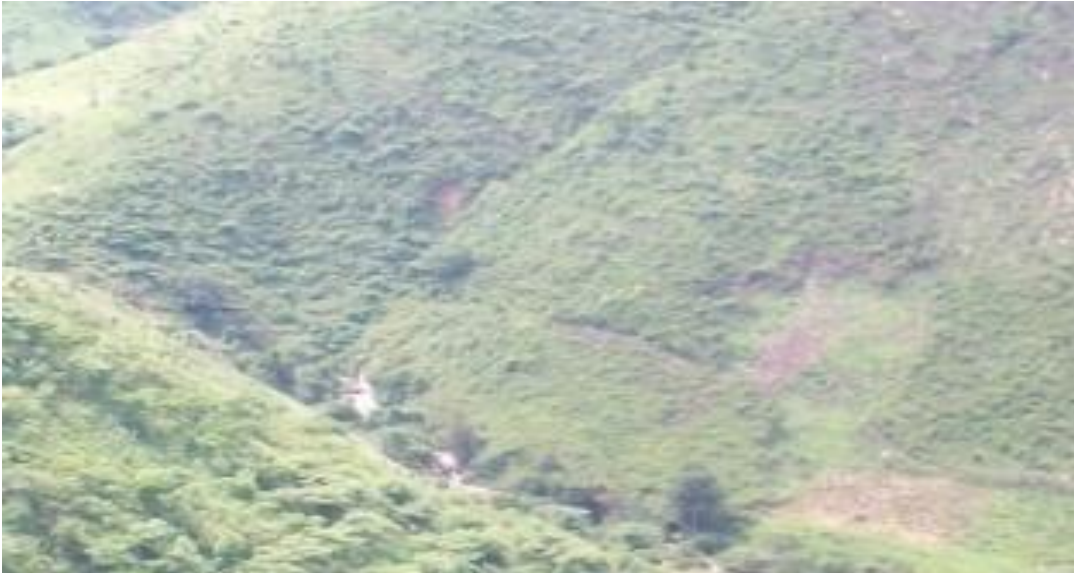
**Plate 4. 4: Clearance of vegetation for cultivation on steep slopes in Oroba water catchment (Source: Author ,2012).**

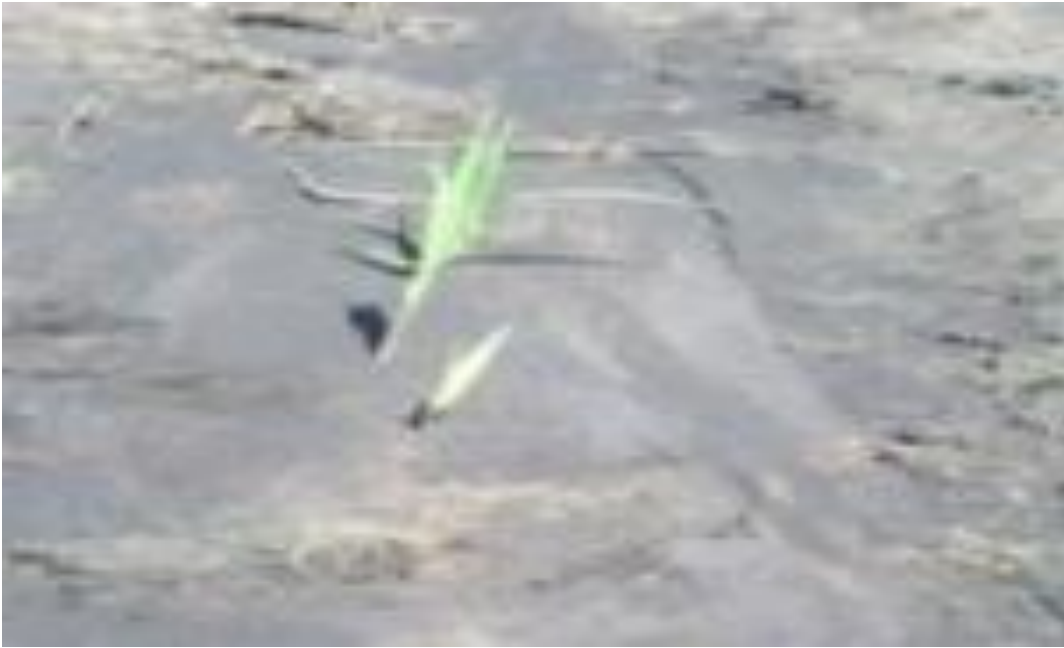
**Plate 4. 6: Young sugarcane seed is almost being washed in a nuclear sugar estate (Source; Author, 2012).**

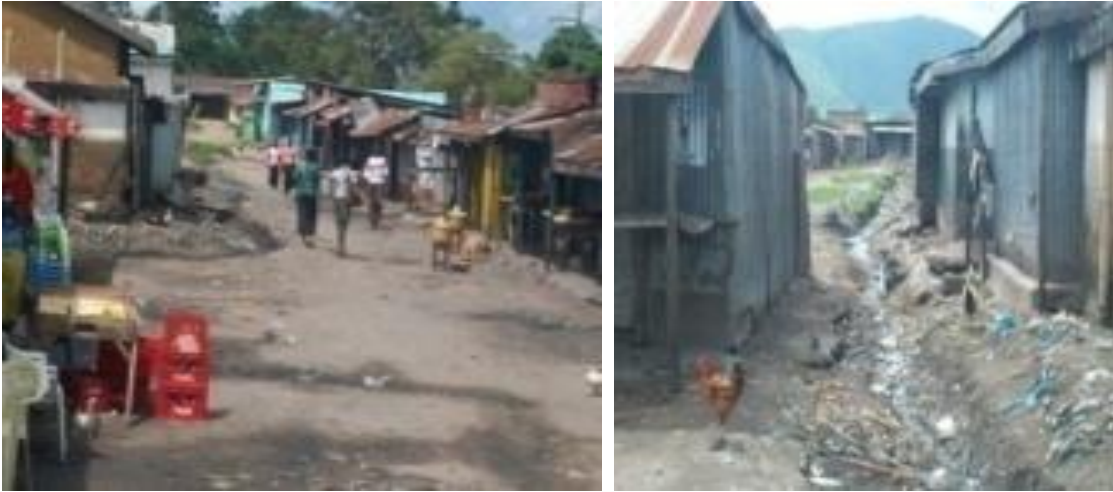
**Plate 4. 7: Unplanned town and trading centres drain sewers into rivers and streams in Oroba water catchment (Source: Author, 2012).**

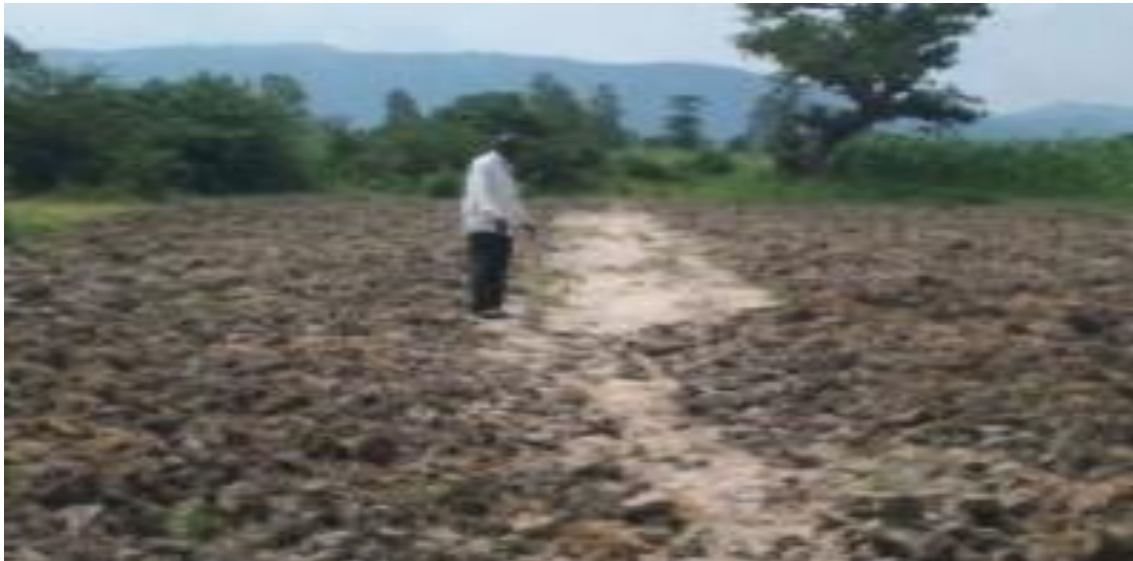
**Plate 4. 8: A rill is forming in the farm in lower Oroba water catchment (Source: Author, 2012)**

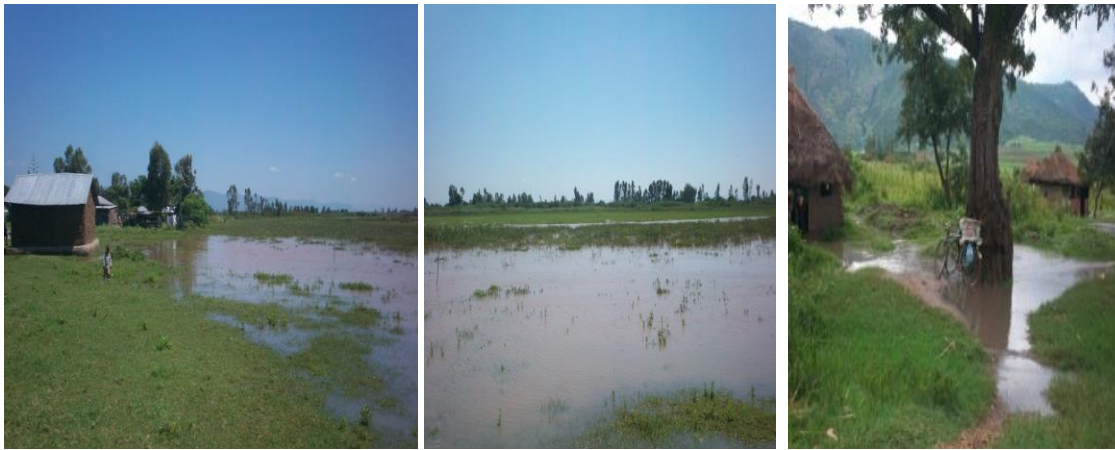
**Plate 4. 10: Flooded homes and farms in Lower Oroba water catchment-Kano plains (Source:Author,2012)**

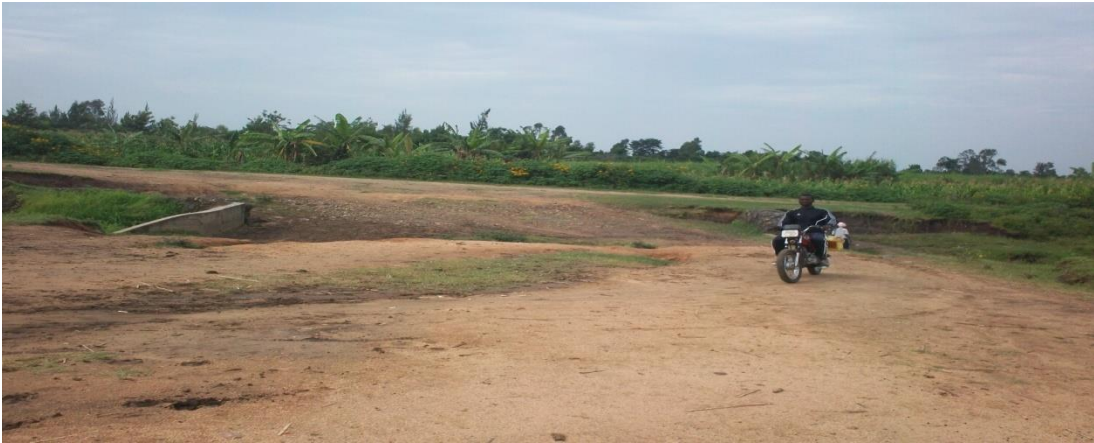
**Plate 4. 11: A bridge across river Oroba is almost being washed away by floods (Source: Author, 2012).**

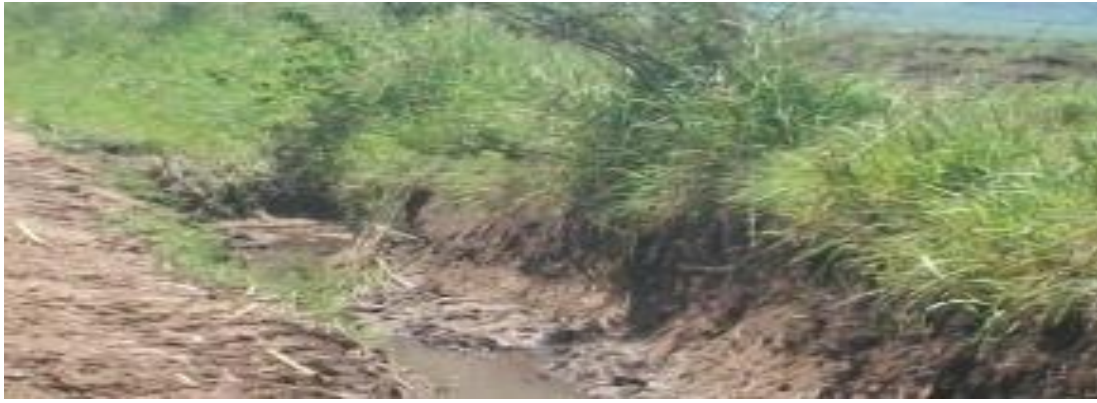
**Plate 4. 12: River bank erosion and siltation occurring in lower Oroba water catchment (Source: Author,2012).**

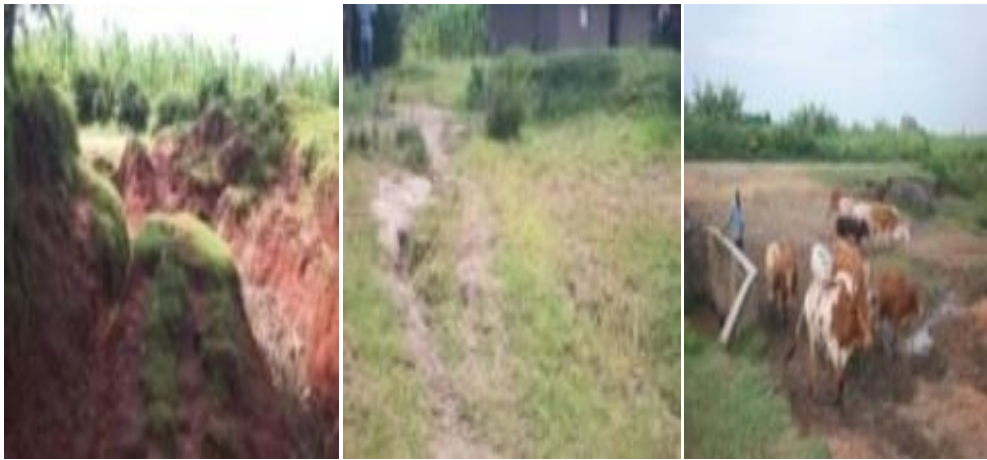
**Plate 4. 15: Water erosion effect on land in the Upper, Middle and Lower Oroba water catchment(Source:Author,2012)**

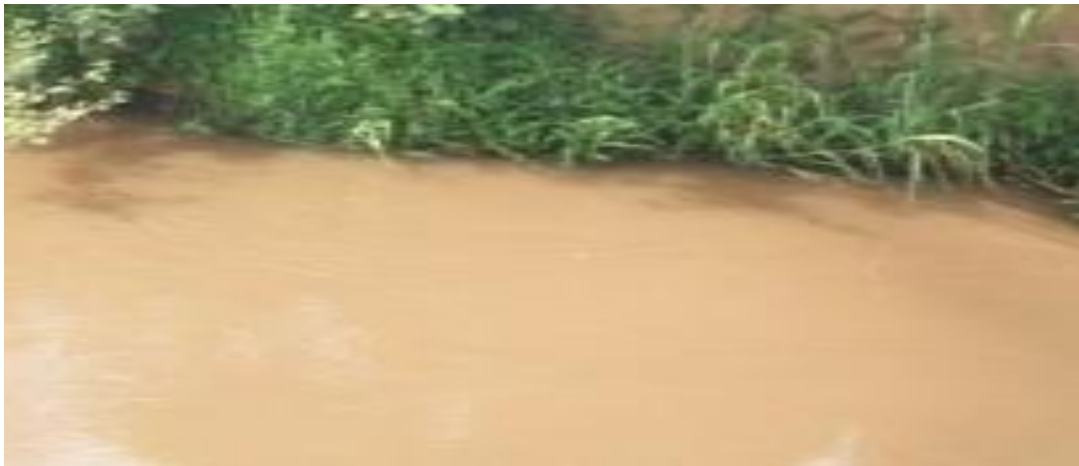
**Plate 4. 17: Observed turbid waters in river Oroba Lower water catchment**
