HOUSING ACCESSIBILITY: A STUDY OF RETROFITTING EFFICIENT RAMPS IN PUBLIC BUILDINGS IN KISUMU CITY, KENYA

A THESIS PRESENTED TO THE SCHOOL OF EDUCATION IN PARTIAL FULFILLMENT OF THE REQUIREMENTS FOR THE AWARD OF THE DEGREE OF MASTER OF EDUCATION IN TECHNOLOGY EDUCATION UIVERSITY OF ELDORET

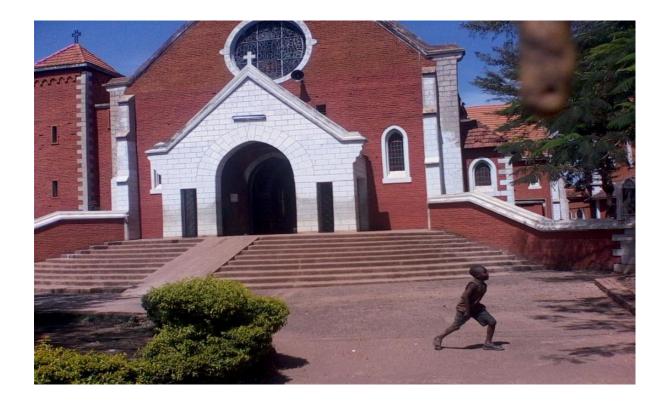
Figure2.1 Main Entrance to a Church in Kisumu City: The ramp superimposed on the stair nosings is too steep to be used by wheelchair bound persons unaided. **Source** (Author, 2014)

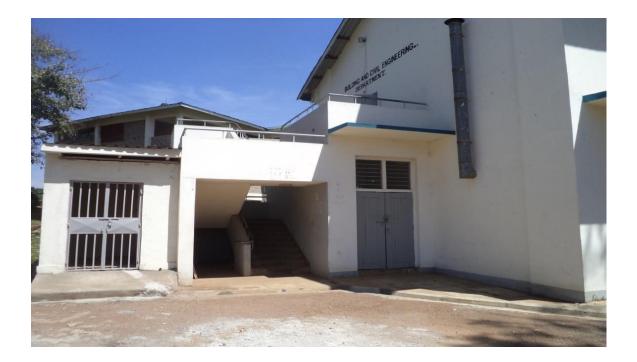
Figure 2.2: Main Entrance to a Building Department in a National Polytechnic in Kisumu City, Kenya. The first floor cannot be accessed by wheelchair users.

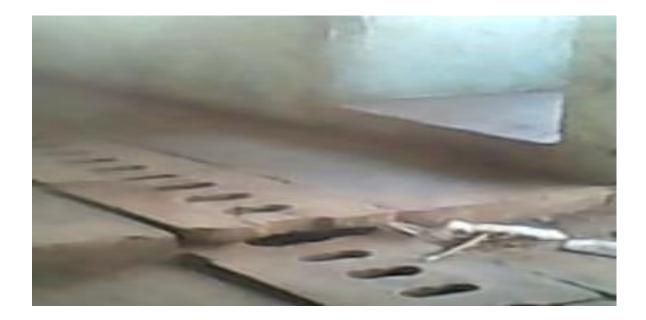
Figure 2.3: Ground Floor of a Public Market in Kisumu, Kenya.

The surface is a barrier to wheelchair users. Source (Author, 2014)

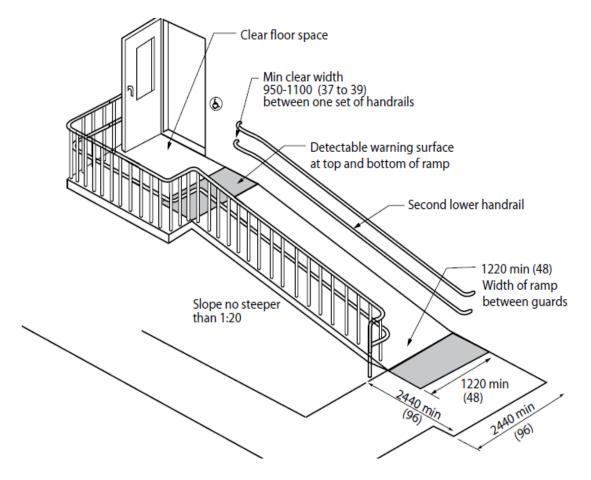
Figure 2.4: Ramp manoeuvring Criteria (City of Winnipeg design guide, 2010)

In a retrofit situation where it is technically not feasible to provide a ramp with a ramp slope between1:15 (6.7%) and 1:20 (5%), a ramp slope not steeper than 1:12(8.3%) may be used. However, more gradual slopes are preferred. Ramps shall have landings that are level both at the top and bottom of each run and also where the ramp changes direction. The horizontal length between landings shall not exceed 9 m. The code gives the ramp maneuvering criteria as shown.

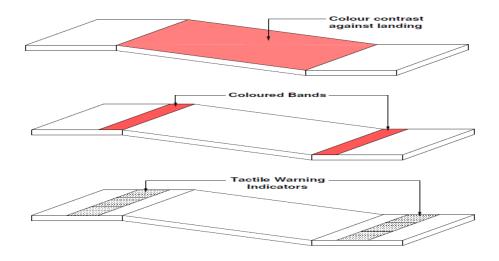
Figure 2.5: Contrasted Colours, Coloured Bands or Tactile Warning Indicators on Ramps (Singapore accessibility Code, 2007)

Where the change in slope is more than 13 mm to 200mm; the ramp and its landings shall be of contrasting colour; or a coloured strip shall be painted across the landings of the ramp. Alternatively, tactile marks may be provided instead of coloured band. The tactile indicators shall be set back 300mm from the edge of the ramp.

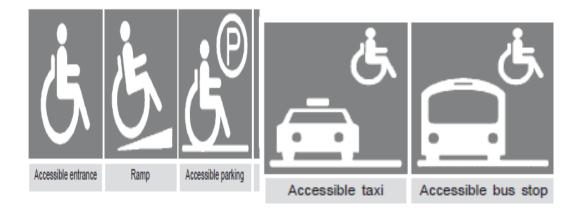
Figure 2.6: Accessibility Signs. (India Barrier Free Design Manual ,2004)

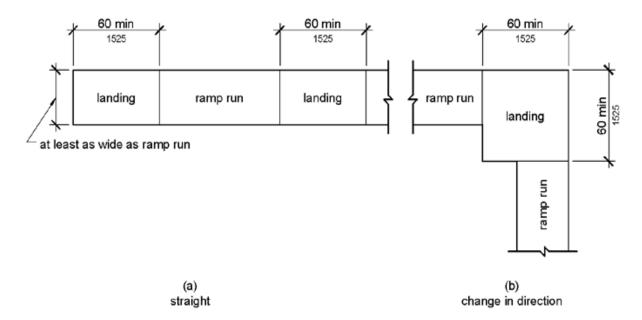
Figure 2.8: Ramp landings (ADA 2010 standards)

Clear Width: The minimum clear width of a ramp shall be 915 mm. **Landings**: Ramps shall have horizontal landings at top and bottom of each ramp span. Landings shall have the following features: the landing shall be at least as wide as the ramp span leading to it. The length of the landing shall be a minimum of 1525 mm clear. When a ramp changes direction at landings, the landing shall at least 1525 mm by 1525 mm. **Handrails:** If a ramp runs has a rise greater than 150 mm or a horizontal projection greater than 1830 mm, then it shall have handrails on both sides. Handrails are not required on curb ramps or adjacent to seating in assembly areas. The Handrails shall be provided along both sides of ramp segments. The inside handrail on switchback or dogleg ramp shall always be continuous.

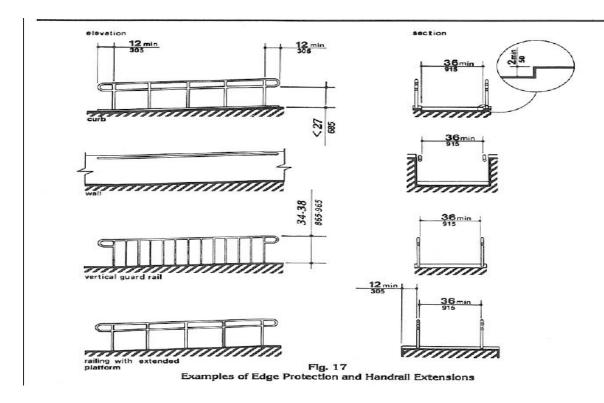
Figure 2.10: Examples of Edge Protection and Handrail Extension (ADA 2010 standards)

The ramp segment shall extend at least 305 mm beyond the top and bottom as well as be parallel with the floor or ground surface if the handrail is not continuous (see Fig. 2.7). The handrail shall continue to slant for a distance of the width of one tread from the bottom riser at the bottom. The remainder of the extension shall be level. **Handrail extensions:** shall comply with the following; a clear space between handrails and wall shall be 38 mm. Gripping surfaces shall be uninterrupted by newel posts, other construction elements, or obstructions. Top of handrail gripping surface shall be mounted between 865 mm and 965 mm above stair nosings. Ends of handrail bars shall be either rounded or returned smoothly to floor, wall or post. Figure 2.10 shows various handrail protections that can be utilized on the constructed ramps.

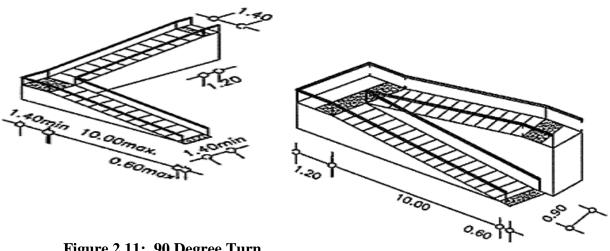
Figure 2.11: 90 Degree Turn Ramp

Figure 2.12: 180 Degree Turn Ramp

Figures 2.8and2.9 ramp turns, Design Manual for a Barrier Free Environment (UN, 2004)

Ramp configuration: Ramps can be constructed to the following forms: Straight-run (fig. 2.14), 90 turn (fig. 2.11); Switchback or 180 turn (fig. 2.12).Width; the width varies according to use, configuration and slope. The minimum width should be 0.9m. Slope; the ramp should be constructed to a slope not exceeding 1:20. Steeper slopes may be allowed in exceptional cases depending on the length to be covered (fig. 2.13). Slope: minimum slope of 1:20 is recommended for un-aided person in a wheelchair. The grade can be increased to 1:14 where the wheelchair user is assisted to ascend. A slope greater than 1:12 is considered a hazard. Width: Varies according to ramp use, configuration and slope, but the minimum is 1m. Landings: Ramps should have landings for resting, manoeuvring and avoiding excessive speed. Landings should be provided every 10m, at the change of direction, top and bottom of every ramp. The landing shall have a minimum span of 1.2m and a width equal to that of the ramp. Handrail: A protective handrail at least 400mm high must be placed along the full length of ramps. For ramps more than 3m wide, an intermediate handrail could be installed. The distance between handrails when both sides are used for gripping should be between 900mm and 1.4m. The ramp surface should be hard, and non-slip-carpets should be avoided. Tactile bands: The top and bottom of the ramp should have a coloured textural to alert blind people as to the location of the ramp.

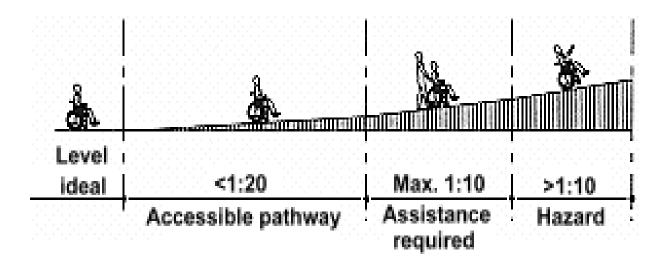
Figure 2.13: Ramp Slopes (UN, 2004 Design manual for barrier free environment)

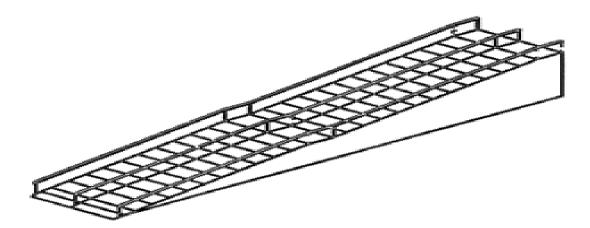
Figure 2.14: Straight Run Ramps (UN, 2004 Design manual for barrier free environment)

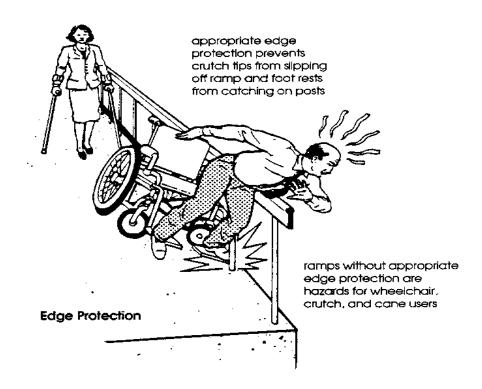
Fig. 2.15: Edge Protection (UFAS Retrofit Manual, 1993)

If existing landings are too small, especially in locations where doors exit onto the landing, then the size of the landing should be increased. Edge protection is required on ramps and landings with drop-offs. Curbs, walls, railings, or extending surfaces which prevent people from slipping off the ramp qualify as edge protection. If curbs are used, they shall be a minimum of 50mm high. Solid walls on each side of a ramp with wall-mounted handrails or very high curbs are the safest edge protection since a wheelchair gone off course will be gently guided down the ramp rather than colliding with the railing.

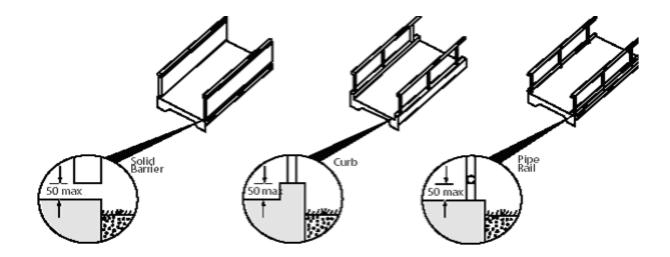
Figure 2.16: Edge Protection at Ramps (City of Brampton code 2005)

Ramp guards shall be not less than 1m measured vertically to the top of the guard from the ramp surface. Besides, they should be designed in such a way that no member, attachment or opening between 150mm and 900mm above the surface being protected by guards will facilitate climbing. Be provided with a curb at least 50mm high on any side of the ramp where no solid enclosure or solid guard is provided; and with railings or other barriers that extend to within 50mm of the finished ramp, or have a curb not less than50mm high. A ramp run with a rise greater than 150mm shall have handrails which are on both sides and

are continuous on the inside of switchback (U-shaped) or dogleg (L-shaped) ramps. When not continuous, it shall; extend horizontally at least 300mm beyond the top and bottom of the ramp and return to the wall, floor, or post, measure between 850mm and 950mm from the ramp surface to the top of the handrail; and have a minimum horizontal distance between handrails of 950mm.

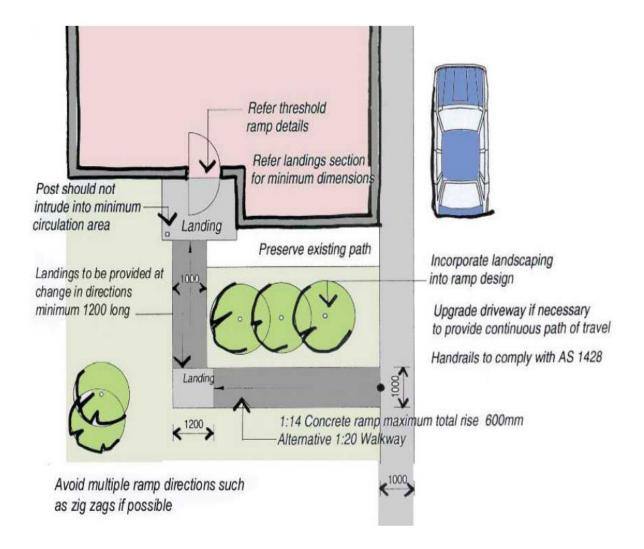
Figure 2.17: Typical Ramp Addition (Australia, 2012 Liveable housing design guidelines)

Where the slope requirement is to be temporary, consideration should be given to temporary modular ramps. Where long ramps are required to accommodate a larger height difference, incorporate landscaping into the design and try to avoid zigzags. The result of this is to reduce the visual impact of the ramp on the house.

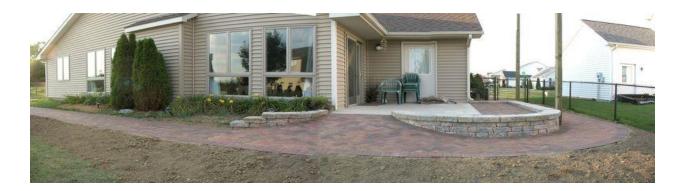
Figure 2.19: Ramp and Walkways (https://web.ics.purdue.edu/~bsd/building.html, 2014)

Another way of making an entrance ramp is by adding a brick patio along the perimeter of existing concrete patio slab. This brick patio gives two uses. First, it provides an appealing ramp with a superb traction. Second, it provides an excellent wheelchair-friendly walkway all around the house that can be of used all year. To maintain proper slope, you have to have to allow for enough ramp length. The breadth of the walkway is 1.4m wide (Duerstock, 2001)

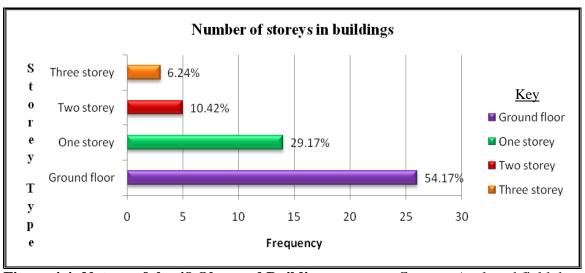
Figure 4.4: Nature of the 48 Observed Buildings Source: Analyzed field data

Figure 4.4 presented the information about the nature of buildings as observed and recorded in the checklist. The bar graph indicates that, of the 48 buildings that were observed, 26(54.17%) were buildings with ground floor only, 14(29.17%) were one storey building, 5(10.42%) were two storey and 3(6.24%) three storey buildings. The findings indicated that a majority of the buildings under study were ground floor buildings.

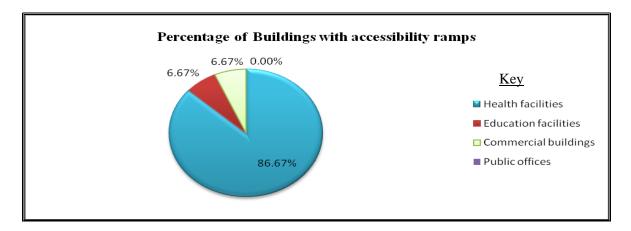
Figure 4.5: Distribution of the 15 Buildings with Access Ramps

From figure 4.5 above, the study established that out of the 15 buildings that had accessibility ramps, 13(86.66%) were Health facilities, 1(6.67%) Education buildings, 1(6.67%) Commercial buildings and 0(0.00%) were Public buildings. The result indicates that all the health facilities studied had access ramps.

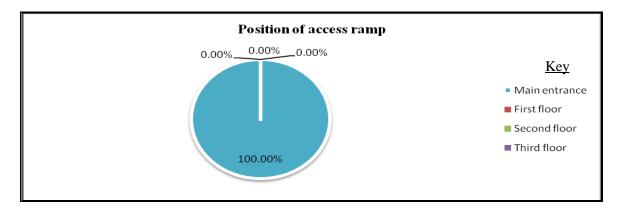
Figure 4.6: Location of the Ramps in the 15 Observed Buildings Source: Analyzed field data

From figure 4.6 above the result indicates that 15 buildings had ramps at the main entrance were at the main entrance and none 0(0%) at first, second and third floors. The data implies that it was easier for owners of buildings to retrofit ramps at the main entrance than at any other position.

The study results on the placement of ramps showed that all of the observed ramps were at the main entrance 15(100%). The ramps are at the main entrance of the building since a
