A Review on Challenges and Opportunities in Management of Soils of Arid and Semi-Arid Regions of Kenya

Article in East African Journal of Environment and Natural Resources · September 2022

East African Journal of Environment and Natural Resources

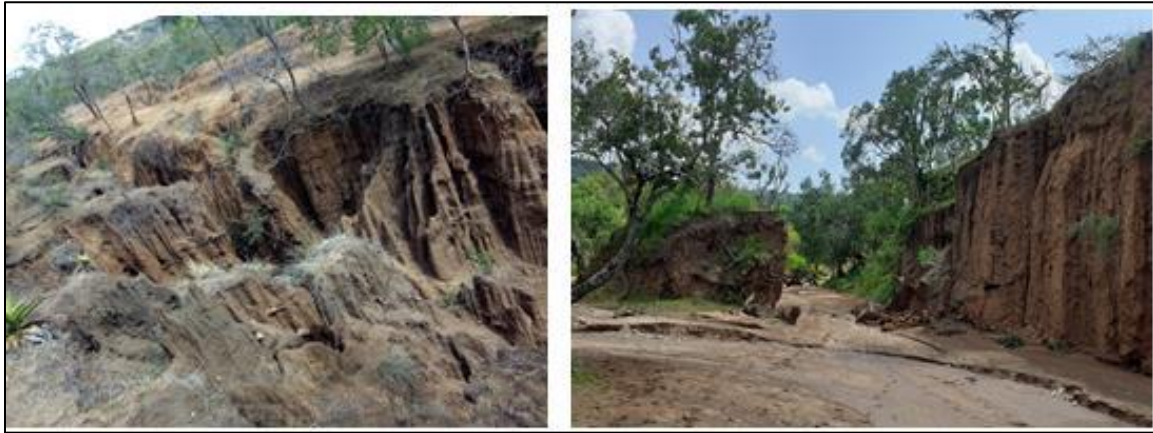
Plate 1: Two types of gullies based on continuity channel, a) braided channels with earth pillars and b) continuous channels with parallel banks

Gully morphology in Kenya varies widely. However, based on shape of the channel. They can be classified into three shapes; entrenched U, trapezoidal, and dendritic V-shaped gullies (Rowntree, 1991). On the other hand, gullies can be classified into continuous channels, which could take any shape described above, or braided shallow channels with earth pillars (Sigunga *et al.*, 2011) as shown in Plate 2. The entrenched dendritic V shaped gullies are prevalent in soils with low infiltration due to sodium rich or a shallow regolith overlying bedrock shaped gully (Rowntree, 1991). The continuous channels occur in soils having high exchangeable sodium, low infiltration especially the lower horizons and highly dispersible. The braided ones occur in soils with high exchangeable sodium in addition to being coarse-textured and an impermeable top layer of hard crust (Sigunga *et al.*, 2011).
